# FACILITY COMPLIANCE INSPECTION REPORT

## Division of Waste Management Solid Waste Section

**Date of Site Inspection:** August 21, 2014

Currin Brothers, Inc. LCID Landfill No. 2  
 1810 Coley Road  
 Durham, NC 27703

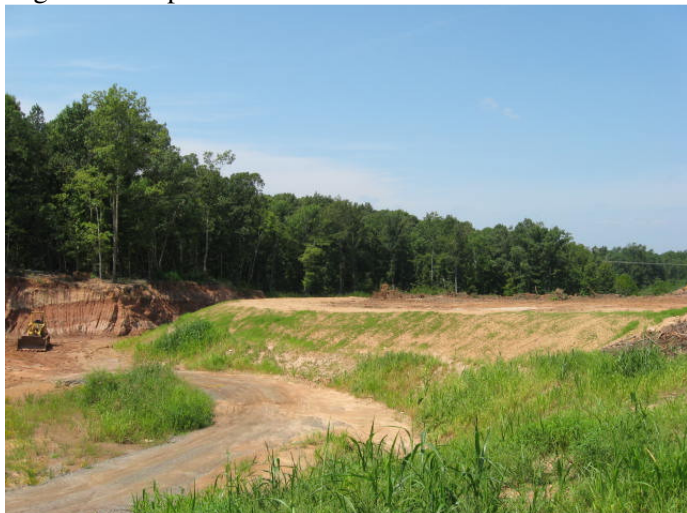
Right side slope – Area 1

20. Non-active areas of the LCID landfill contained vegetative ground cover.
21. The LCID landfill side slopes should be routinely mowed.

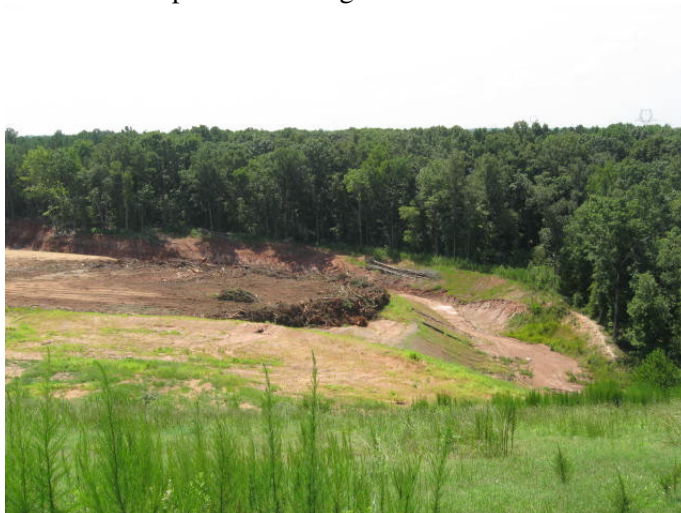
10. The working face at Area 1 was ~ 200' in length and the one at Area 3 was ~ 100' in length. Each working face was located along a section of the Area perimeter. Working face lift was ~ 10' in height.

11. The top of each lift was covered with soil such that mainly the side slope was exposed.
12. Mr. LaFerire stated that each lift/working face is covered with soil, to include the side slope, ~ every 15 days. Until additional personnel arrive to grade and cover a working face, two open areas are exposed but only one working face accepts material.

Left side slope and working face - Area 1

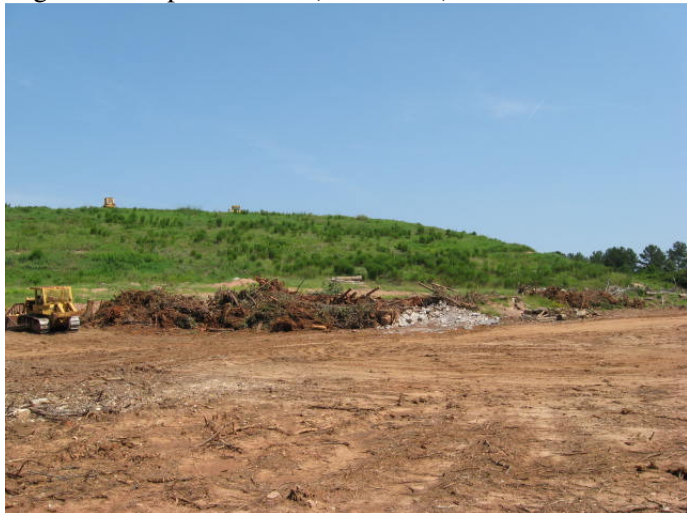
Right side slope – Area 3 (front view)

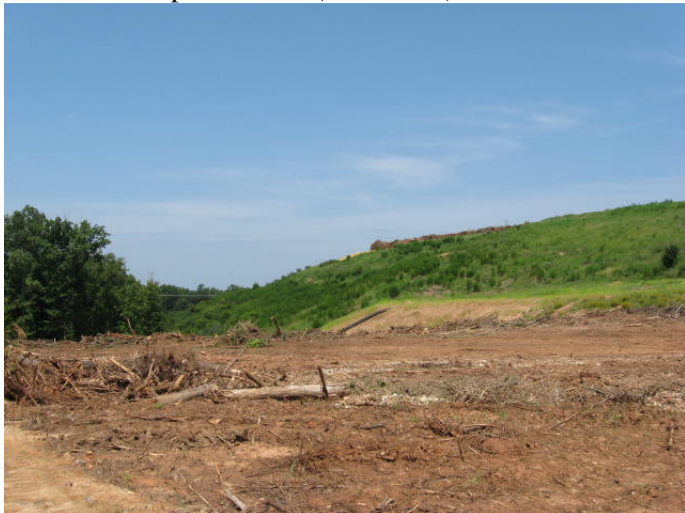
Left side slope – Area 3 (front view)

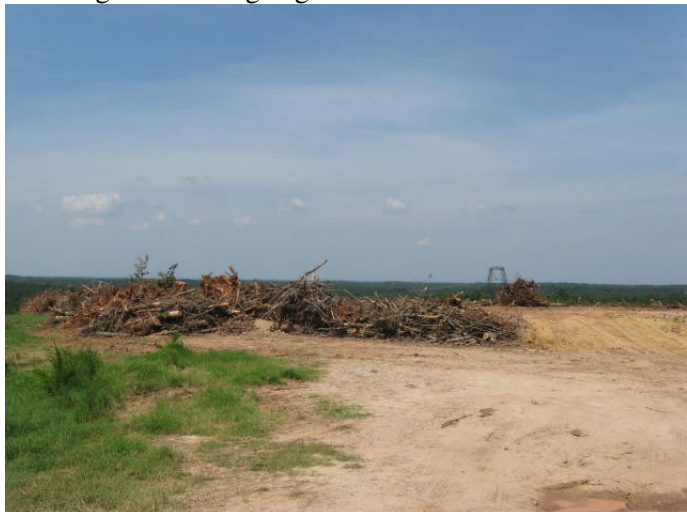
Working face leading edge – Area 3

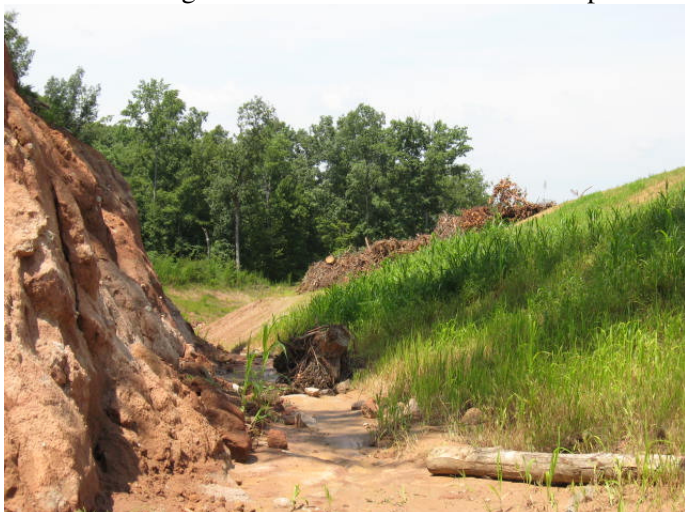
Channel along embankment and Area 1 side slope

18. Edge of waste markers, green metal stake with orange ribbon, have been installed.
19. Ensure the channel between the leading edge of Area 1 and the embankment of the adjacent natural area is graded and maintained accordingly to prevent soil runoff and ponding of water and that the sediment basin is maintained in good order.

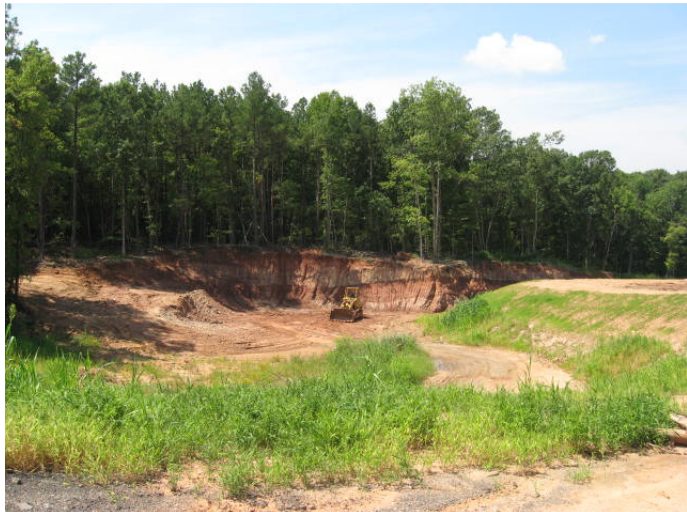
13. Soil is mined on site to sell and use as cover material.
14. Mr. Currin stated that the facility has not conducted the purposed Temperature Management Demonstration (submitted to SWS, dated November 27, 2013). And that all material, to include side slopes, is covered with soil sooner than the required 30 days.

Soil mine area
